Civil Works Hydropower R&D Program

Cavitation-Resistant Coatings for Hydropower Turbines

Ryan Sollars and Alfred D. Beitelman

June 2011

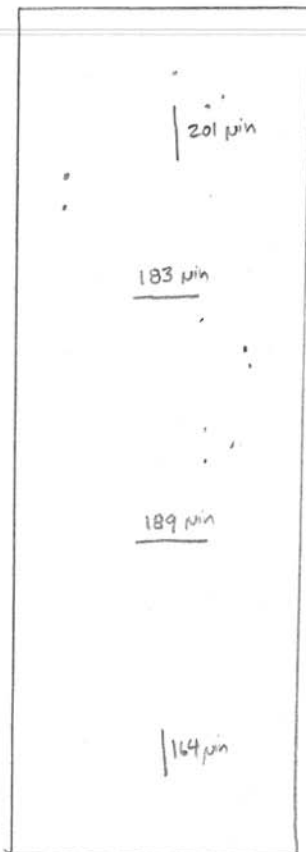
TEST BUCKET #2

photos: 350, 351

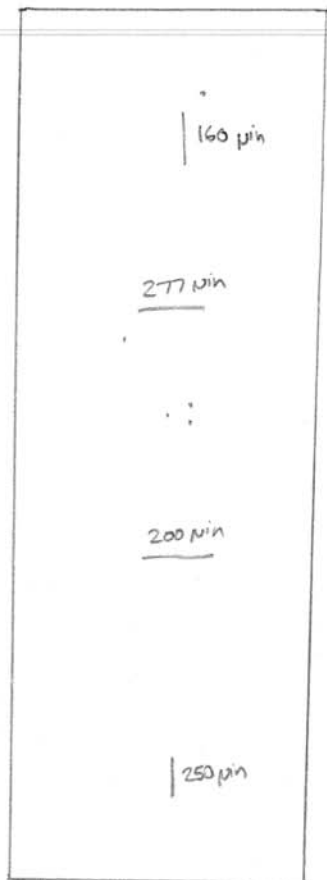
TEST BUCKET #4

photo 353

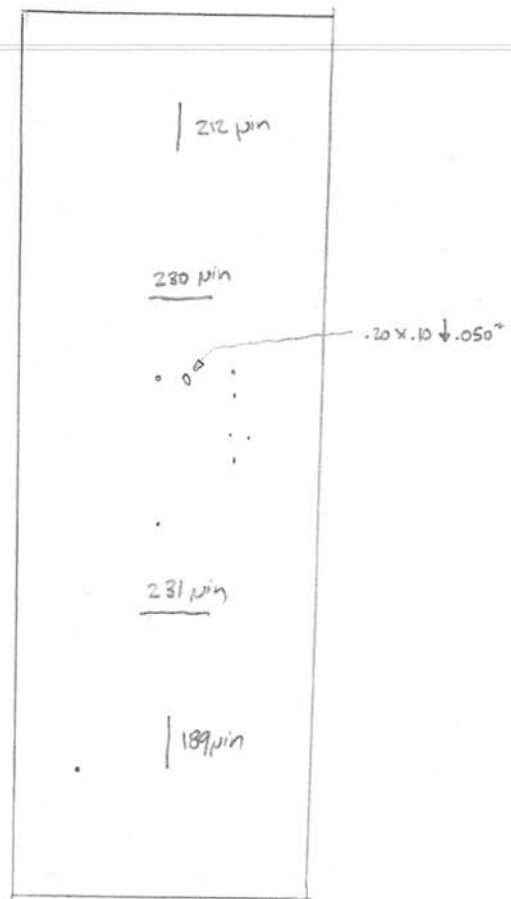
TEST BUCKET #3

photos 348, 349

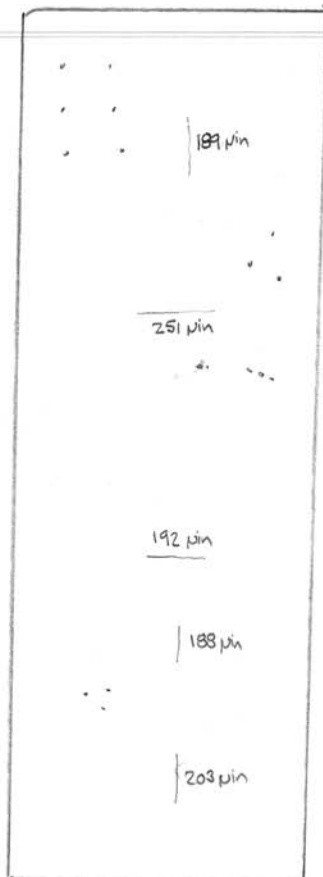
TEST BUCKET #1

Photos: 362, 363, 364, 365, 366

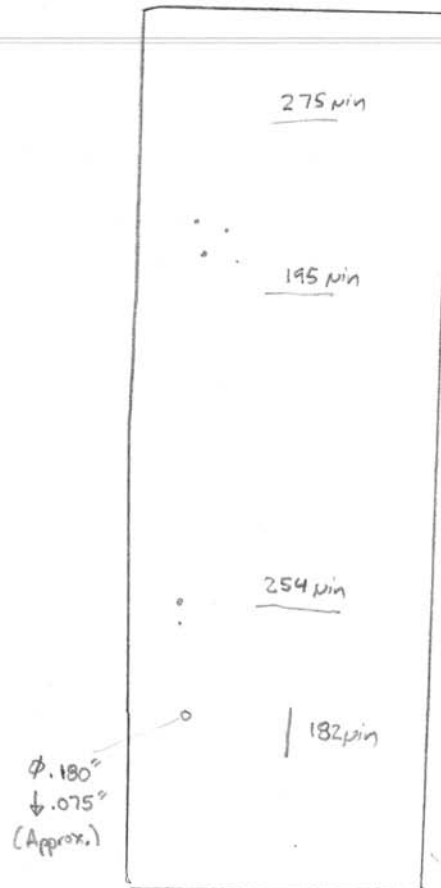
TEST BUCKET #7

Photos: 359, 360, 361

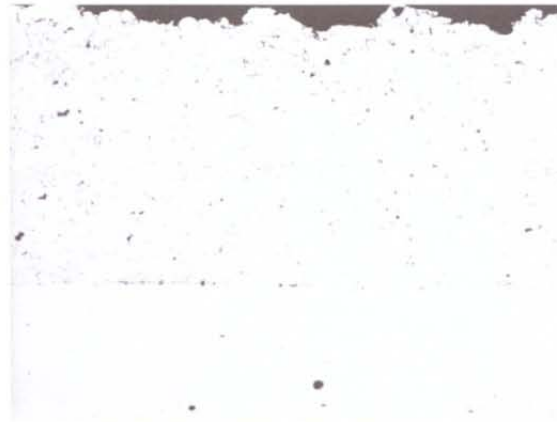
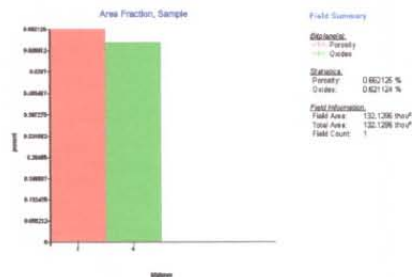
Work Order #:	18668	Application Spec:	AMS 2447
Purchase Order #:	W9127N-10-Q-0002	Lab. Technician:	Ricky Lee
Customer:	U.S. Army Green River Dam Project	Objective:	200X
Material:	Nano Steel 9172 SHS Lot # 08-050	Applicator:	Ricky T.
Date:	11/23/09	Sample Number:	1T-B
Acceptance Criteria			
Cracks (None)	NONE	Porosity Max 2%	0.66%
		Interface Contamination No Delam.	Acceptable No Delam.
		Oxide Max 1%	0.62%
Unmelted Particles Max 0.01%	Acceptable	Abrasive Particles	Acceptable

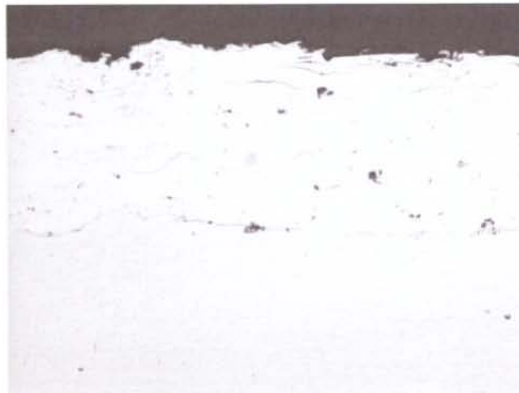
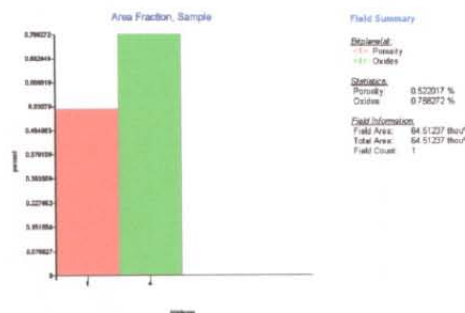
Work Order #:	18668	Application Spec:	AMS 2447
Purchase Order #:	W9127N-10-Q-0002	Lab. Technician:	Ricky Lee
Customer:	U.S. Army Green River Dam Project	Objective:	200X
Material:	Vecalloy Lot # 07-227	Applicator:	Ricky T.
Date:	11/23/09	Sample Number:	2T-B
Acceptance Criteria			
Cracks (None)	NONE	Porosity Max 2%	0.52%
		Interface Contamination No Delam.	Acceptable No Delam.
		Oxide Max 1%	0.75%
Unmelted Particles Max 0.01%	Acceptable	Abrasive Particles	Acceptable

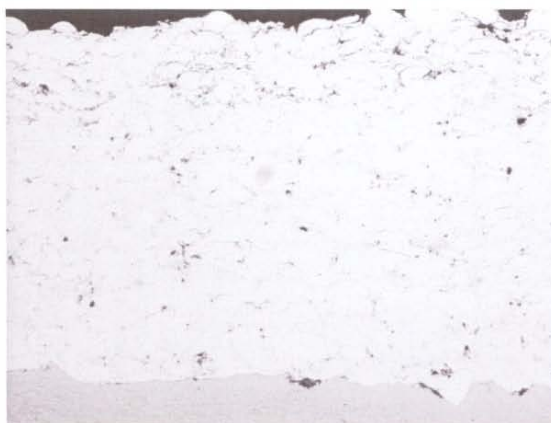
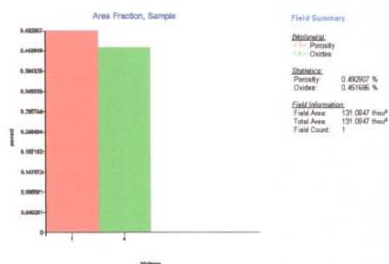
Work Order #:	18668	Application Spec:	AMS 2447
Purchase Order #:	W9127N-10-Q-0002	Lab. Technician:	Ricky Lee
Customer:	U.S. Army Green River Dam Project	Objective:	200X
Material:	Stellite Ultimet Lot # 5090137-2	Applicator:	Ricky T.
Date:	11/23/09	Sample Number:	3T-B
Acceptance Criteria			
Cracks (None)	NONE	Porosity Max 2%	0.49%
		Interface Contamination No Delam.	Acceptable No Delam.
Unmelted Particles Max 0.01%	Acceptable	Abrasive Particles	Acceptable
		Oxide Max 1%	0.45%

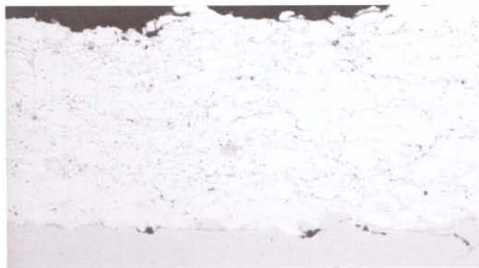
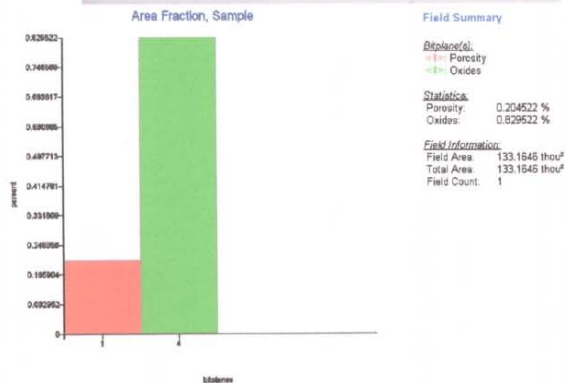
Work Order #:	18668	Application Spec:	AMS 2447
Purchase Order #:	W9127N-10-Q-0002	Lab. Technician:	Ricky Lee
Customer:	U.S. Army Green River Dam Project	Objective:	200X
Material:	Praxair Co-106-1 Lot # 46 Ref. Stellite 6	Applicator:	Ricky T.
Date:	11/24/09	Sample Number:	4T-A
Acceptance Criteria			
Cracks (None)	NONE	Porosity Max 2%	0.20%
		Interface Contamination	Acceptable
		No Delam.	No Delam.
Oxide Max 1%			0.82%
Unmelted Particles	Acceptable	Abrasive Particles	Acceptable

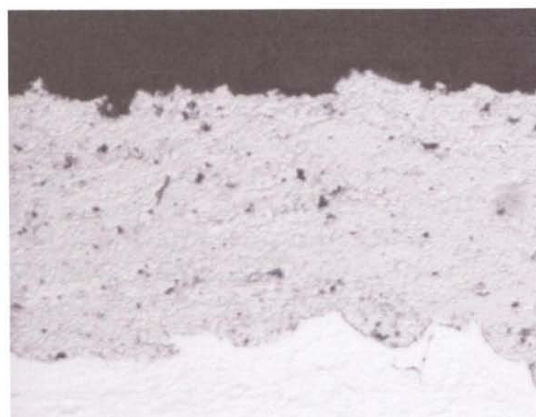
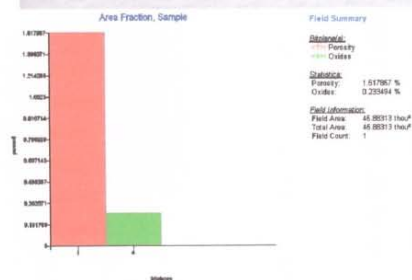
Work Order #:	18668	Application Spec:	AMS 2447
Purchase Order #:	W9127N-10-Q-0002	Lab. Technician:	Ricky Lee
Customer:	U.S. Army Green River Dam Project	Objective:	200X
Material:	Praxair 1350VM Lot # 418	Applicator:	Ricky T.
Date:	11/23/09	Sample Number:	5T-A
Acceptance Criteria			
Cracks (None)	NONE	Porosity Max 2%	1.51%
		Interface Contamination	Acceptable
		No Delam.	No Delam.
Unmelted Particles Max 0.01%	Acceptable	Abrasive Particles	Acceptable
		Oxide Max 1%	0.23%

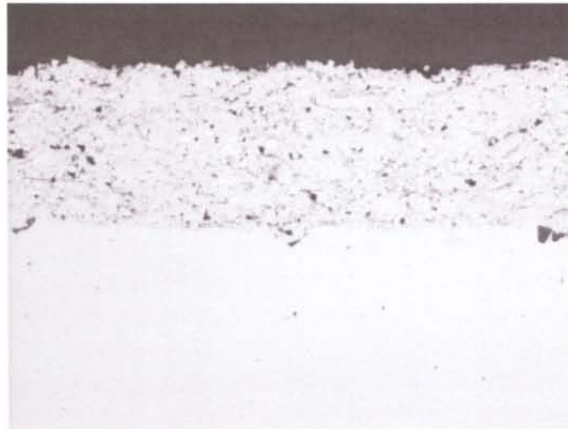
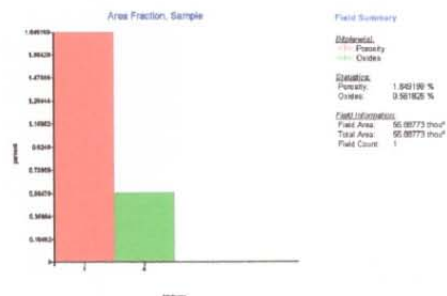
Work Order #:	18668	Application Spec:	AMS 2447
Purchase Order #:	W9127N-10-Q-0002	Lab. Technician:	Ricky Lee
Customer:	U.S. Army Green River Dam Project	Objective:	200X
Material:	Amperit 588.074 Lot # 4100900	Applicator:	Ricky T.
Date:	11/23/09	Sample Number:	6T-A
Acceptance Criteria			
Cracks (None)	NONE	Porosity Max 2%	1.84%
		Interface Contamination No Delam.	Acceptable No Delam.
		Oxide Max 1%	0.56%
Unmelted Particles Max 0.01%	Acceptable	Abrasive Particles	Acceptable

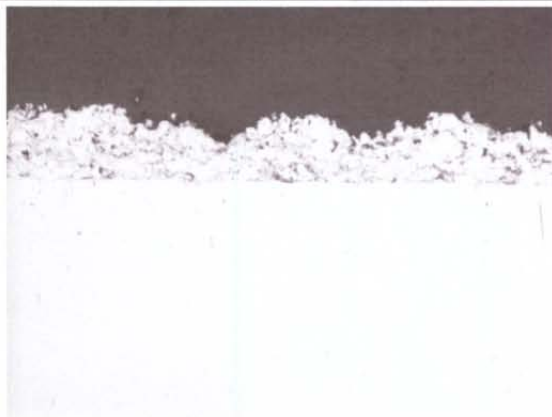
Work Order #:	18668	Application Spec:	AMS 2447
Purchase Order #:	W9127N-10-Q-0002	Lab. Technician:	Ricky Lee
Customer:	U.S. Army Green River Dam Project	Objective:	200X
Material:	Amperit 584.1 Lot # 4220840	Applicator:	Ricky T.
Date:	11/23/09	Sample Number:	7T-B
Acceptance Criteria			
Cracks (None)	NONE	Porosity Max 2%	1.89%
		Interface Contamination No Delam.	Acceptable No Delam.
Unmelted Particles Max 0.01%	Acceptable	Abrasive Particles	Acceptable
		Oxide Max 1%	0.89%

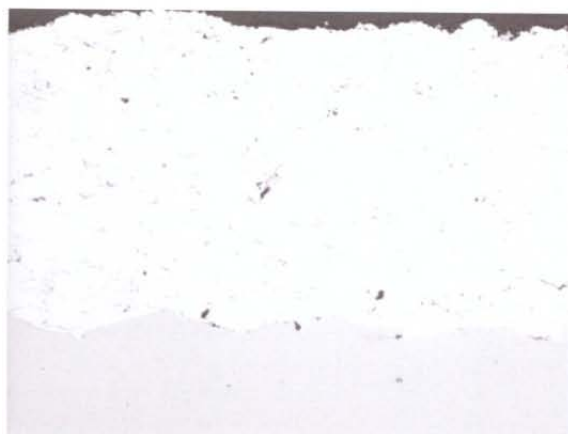
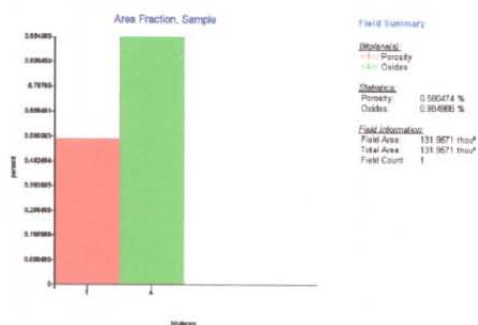
Quality Control Microstructure Examination Report		Flame Spray Inc. 4674 Alvarado Canyon Rd. San Diego, CA 92120 619-283-2007	
Work Order #:	18668	Application Spec:	AMS 2447		
Purchase Order #:	W9127N-10-Q-0002	Lab. Technician:	Ricky Lee		
Customer:	U.S. Army Green River Dam Project	Objective:	200X		
Material:	Stellite 21 Lot # 5090136-2	Applicator:	Ricky T.		
Date:	11/24/09	Sample Number:	8T-A		
Acceptance Criteria					
Cracks (None)	NONE	Porosity Max 2%	0.58%	Interface Contamination No Delam.	Acceptable No Delam.
				Oxide Max 1%	0.98%
Unmelted Particles		Acceptable		Abrasive Particles	
				Acceptable
